Manhole Inspection Summary

Manhole # S43C__017MH

Insp Date: **4/13/08 9:09 AM**

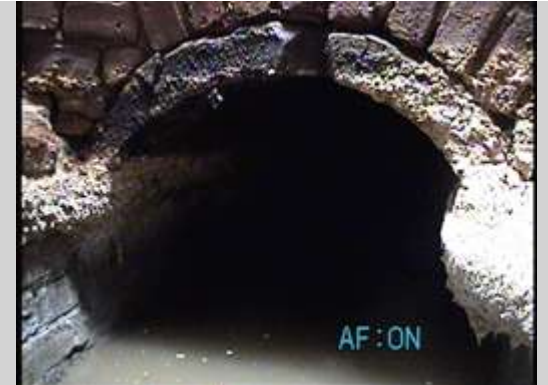
12 O'Clock Outflow

24 in. Circular Gravity Sewer
Drop Out @ 12 O'Clock

Pipe Height: **24** (in.) Rod and Bar (Angled)
Pipe Material: **Clay** ☐ Pipe Lined
Invert Depth: **11.00** (ft.) Flow Characteristics: **Slow**
Deposits: ☒ None ☐ Mud ☐ Sludge ☐ Debris ☐ Grease
Silt Depth: (in.) Deposits Extent:
Infiltration: **None** Pipe Seal Cond: **Unknown**

Drop: **None**

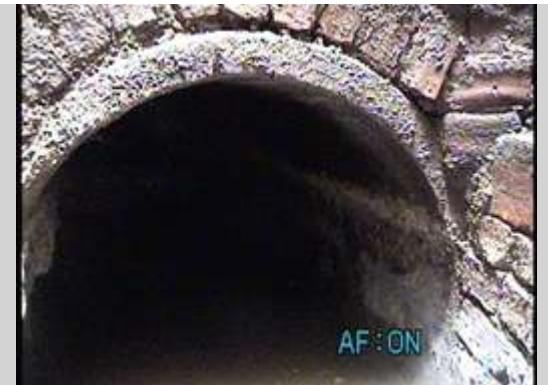
6 O'Clock Inflow

24 in. Circular Gravity Sewer
Pipe In @ 6 O'Clock

Pipe Height: **24** (in.) Rod and Bar (Angled)
Pipe Material: **Clay** ☐ Pipe Lined
Invert Depth: **11.00** (ft.) Flow Characteristics: **Slow**
Deposits: ☒ None ☐ Mud ☐ Sludge ☐ Debris ☐ Grease
Silt Depth: (in.) Deposits Extent:
Infiltration: **None** Pipe Seal Cond: **Unknown**

Drop: **None**
